INDOOR AIR QUALITY ASSESSMENT

**John J. Duggan Middle School
1015 Wilbraham Road
Springfield, Massachusetts**

Prepared by:
Massachusetts Department of Public Health
Bureau of Environmental Health Assessment
Emergency Response/Indoor Air Quality Program
December 2003

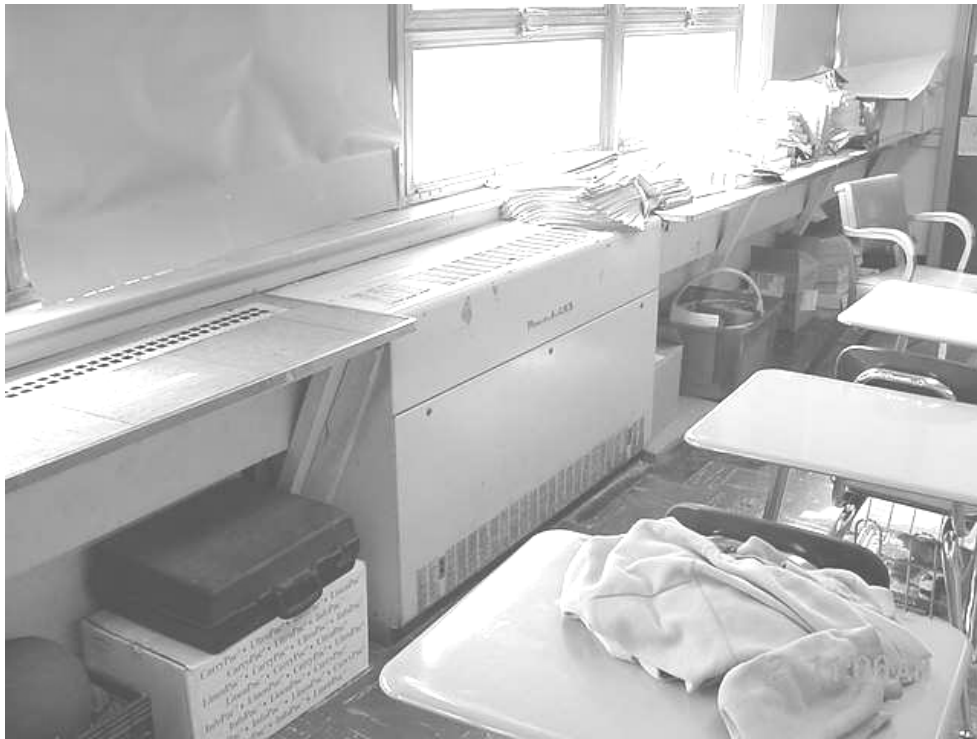
Picture 1

Fresh air in classrooms is supplied by a unit ventilator (univent) system (Picture 1). Univents draw air from outdoors through a fresh air intake located on the exterior walls of the building (Picture 2) and return air through an air intake located at the base of each unit ([Figure 1](#)). Fresh and return air are mixed, filtered, heated and provided to classrooms through an air diffuser located in the top of the unit. Univents were found deactivated in classrooms throughout the school. Obstructions to airflow on and in front of univent returns were seen in a number of classrooms (Picture 3). In order for univents to provide fresh air as designed, these units must remain activated and allowed to operate while these rooms are occupied. Air diffusers and return vents must also remain free of obstructions.

Classroom Univent

1. Examine each univent for function. Survey classrooms for univent function to ascertain if an adequate air supply exists for each room. Consider consulting a heating, ventilation and air conditioning (HVAC) engineer concerning the calibration of univent fresh air control dampers throughout the school.
2. Operate ventilation systems that are operable continuously during periods of school occupancy, independent of thermostat control, throughout the building (e.g., gym, auditorium, classrooms).
3. Inspect exhaust motors and belts for proper function. Repair and replace as necessary.
4. Reactivate exhaust ventilation in restrooms to remove odors and moisture.

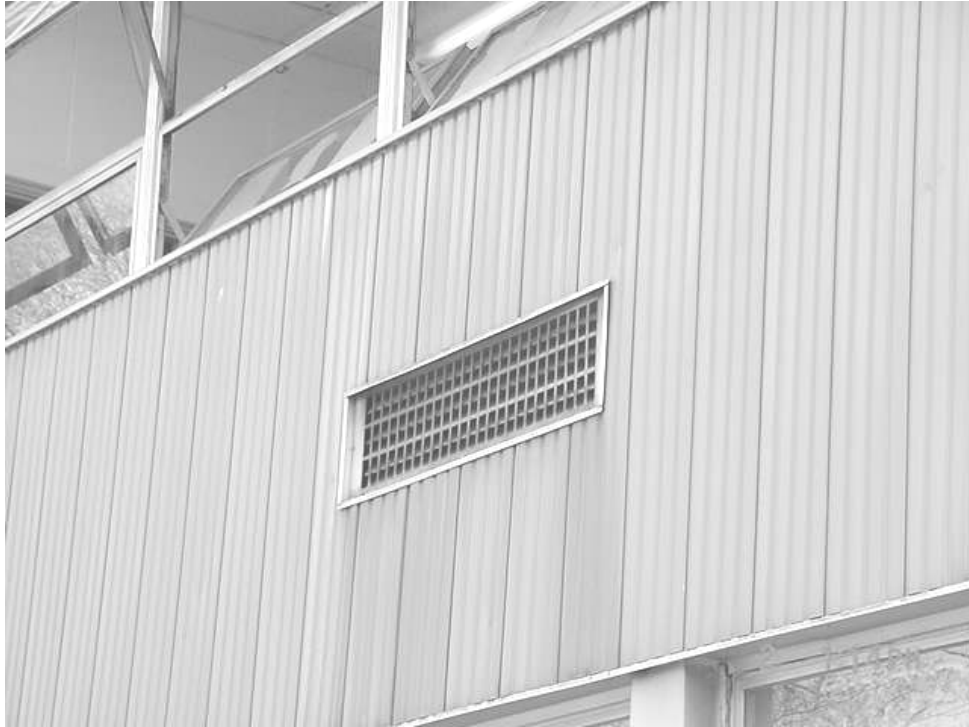
Picture 2

Univent Fresh Air Intake

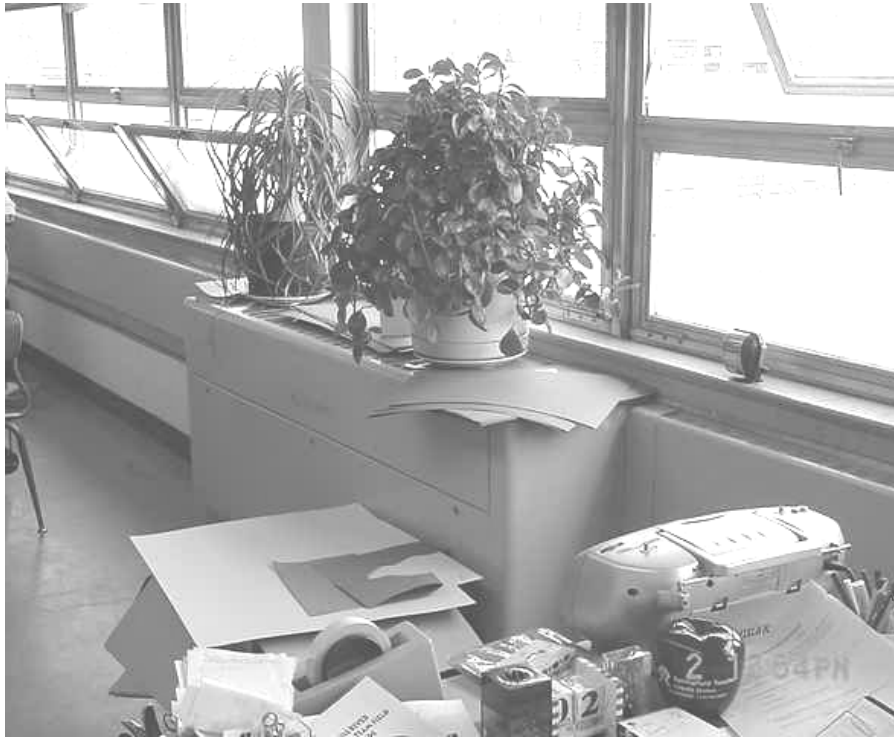
Picture 3

Plants and Other Items on and In Front of Univent, Obstructing Airflow

5. Remove all blockages from univents and exhaust vents to ensure adequate airflow. Keep classroom doors shut to avoid blockage of exhaust vents.
6. Consult a ventilation engineer concerning re-balancing of the ventilation systems. Ventilation industrial standards recommend that mechanical ventilation systems be balanced every five years (SMACNA, 1994).

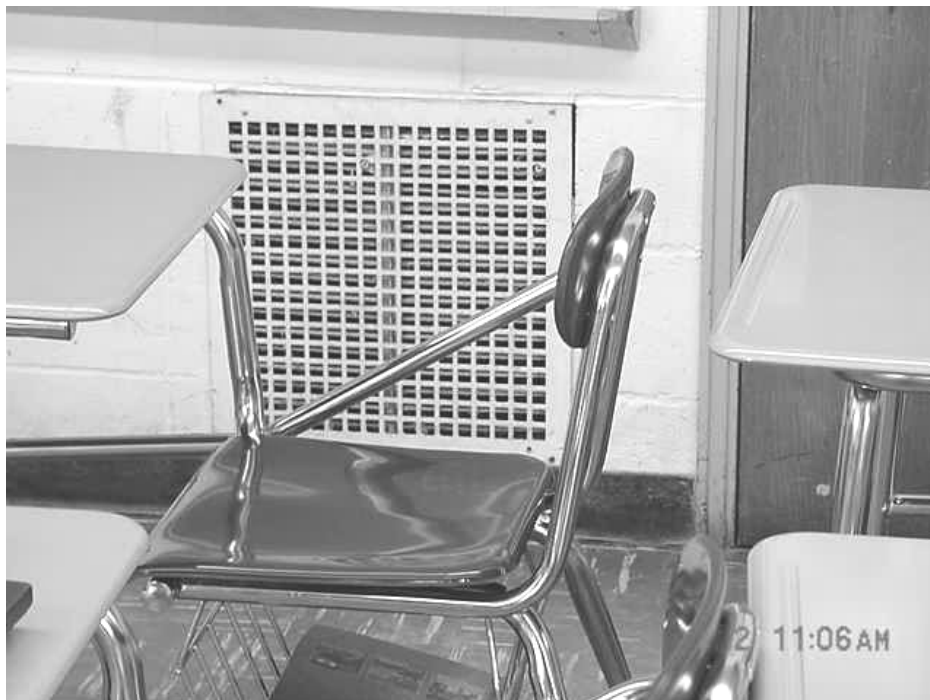
Picture 4

Exhaust ventilation in classrooms is provided by ducted, grated wall vents (Picture 4) powered by rooftop motors. At the time of the assessment a number of exhaust vents were not operating or operating weakly, indicating that motors were deactivated or non-functional. In addition, a number of the vents were blocked by desks, bookcases, and shelving. In some cases, open classroom doors blocked exhaust vents (Picture 5). In such cases, exhaust efficiency can be limited by the location of exhaust vents. When a classroom door is open, exhaust vents will tend to draw air from both the hallway and the classroom. The open hallway door reduces the effectiveness of the exhaust vent to remove common environmental pollutants from classrooms. As with the univents, in order to function properly, exhaust vents must be activated and remain free of obstructions. Without removal by exhaust ventilation, normally occurring environmental pollutants can build up and lead to indoor air complaints.

Classroom Exhaust Vent

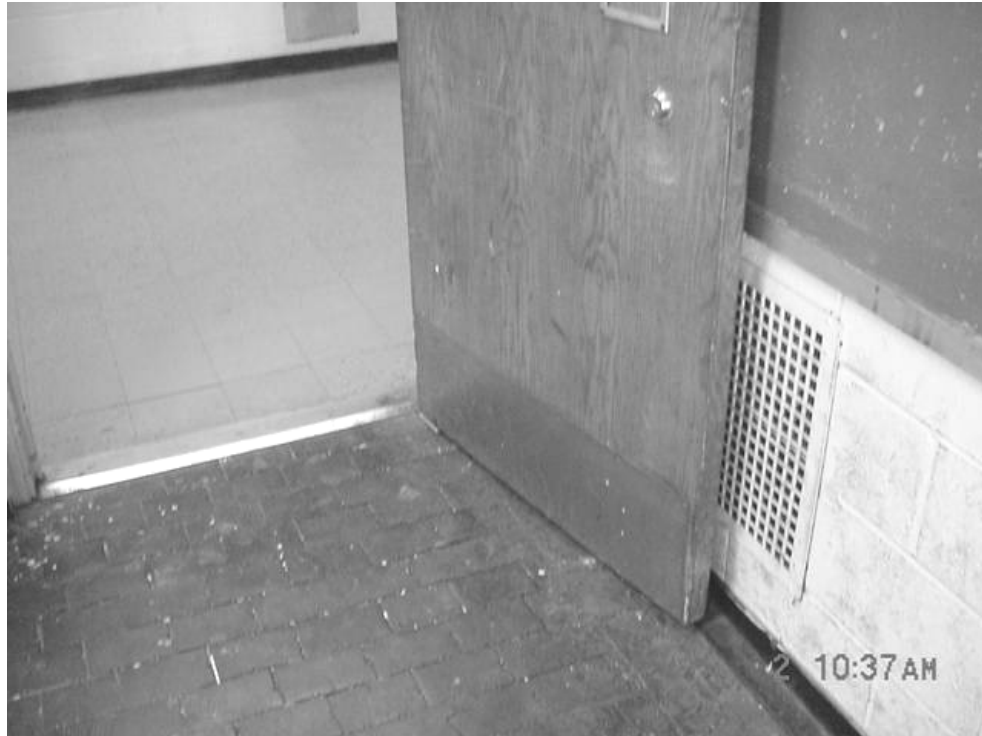
Picture 5

Classroom Exhaust Vent Obstructed by Open Hallway Door

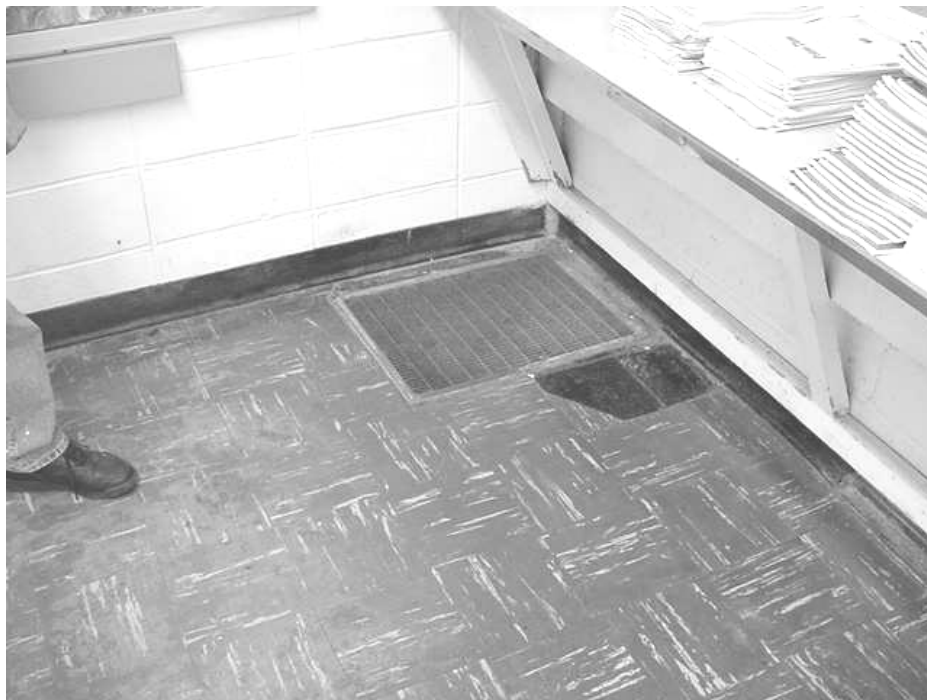
Picture 6

Of note was a grated hole found in the floor of classroom 1 (Picture 6). The purpose of this vent was not readily discernable by BEHA staff. No draw of air was noted, however, it is possible that the hole serves as an exhaust vent. The vent/hole could use the crawlspace beneath the floor of this wing as a duct. If the mechanical ventilation

system this vent belongs to was deactivated, drafts, particulates and odors from beneath the floor can migrate into this classroom.

Grille in floor of classroom 1

8. Ascertain the function of the grill shown in Picture 5A. If it is an exhaust vent, restore the means to provide air movement. If it is not part of the ventilation system, consider sealing this grille.

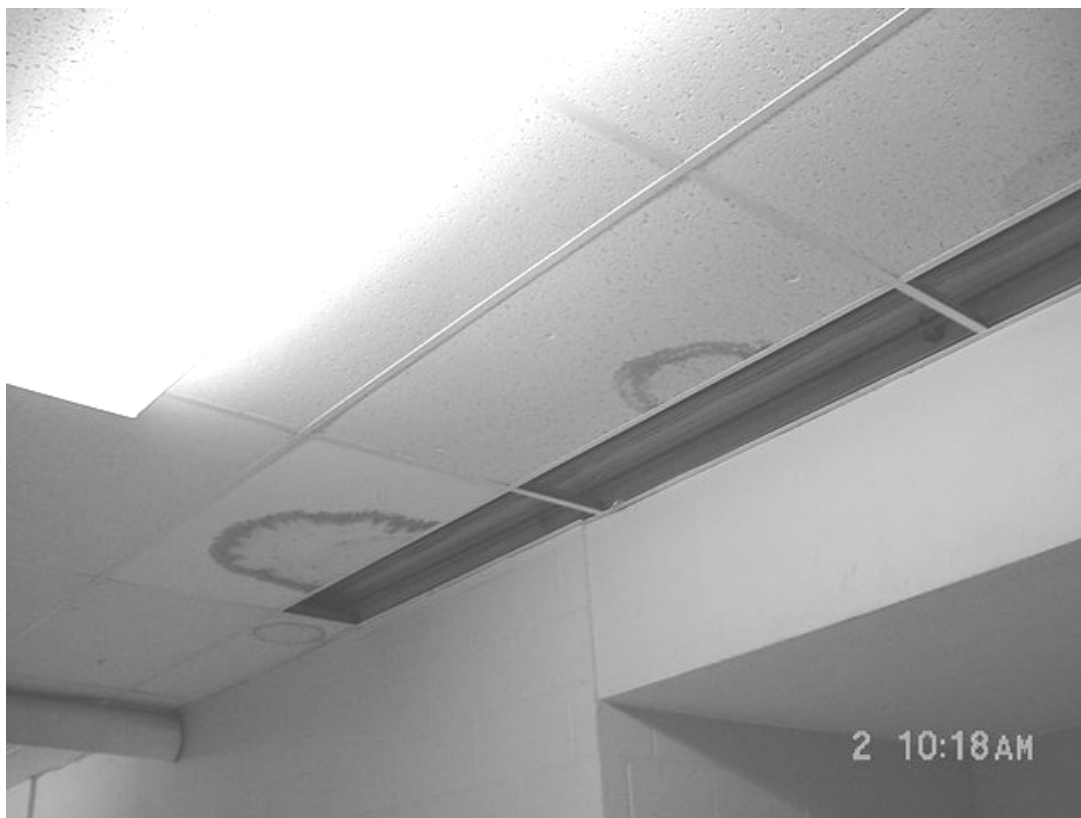
Picture 7

The building has a history of roof leaks. Active leaks were reported in the ground floor hallway outside of the cafeteria and in classroom 211. A number of areas had water-damaged ceiling tiles and plaster (Pictures 7 and 8). Water-damaged ceiling tiles and other porous building materials can provide a medium for mold growth and should be replaced after a water leak is discovered and repaired.

Missing/Water Damaged Ceiling Tiles

12. Isolate and repair water leaks. Repair/replace any water-damaged ceiling tiles, plaster and/or other damaged building materials. Examine above and around these areas for mold growth. Disinfect areas of water leaks with an appropriate antimicrobial. Building occupants should report any roof leaks or other signs of water penetration to school maintenance staff for remediation.

17. Replace missing ceiling tiles to prevent the egress of dirt, dust and particulate matter into classrooms.
18. Relocate or consider reducing the amount of materials stored in classrooms to allow for more thorough cleaning. Clean items regularly with a wet cloth or sponge to prevent excessive dust build-up.

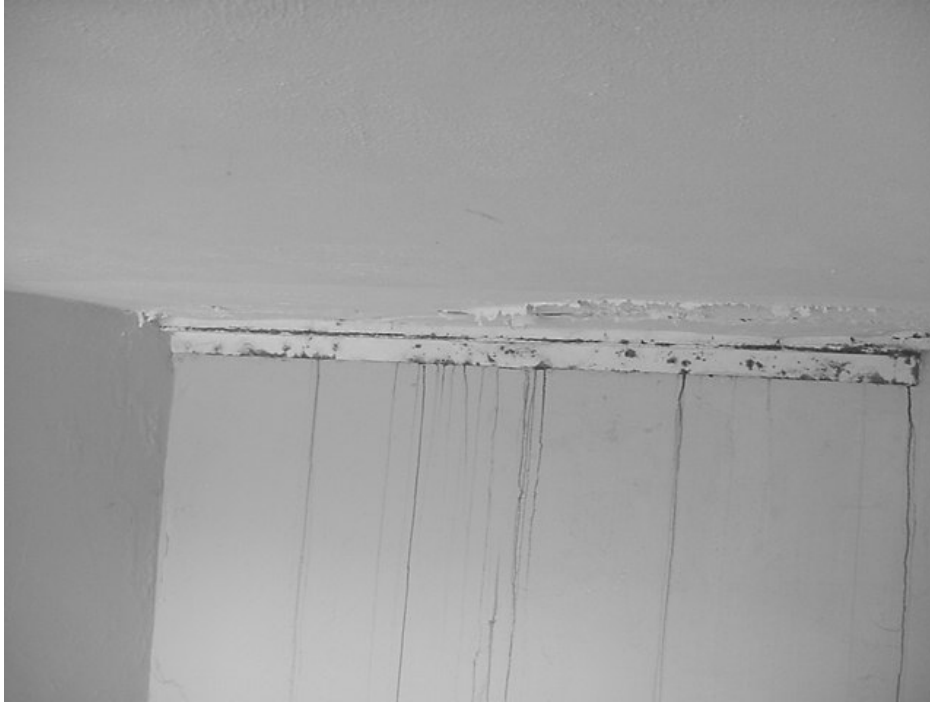
Picture 8

Water Damage along Ceiling, Note Drip Lines

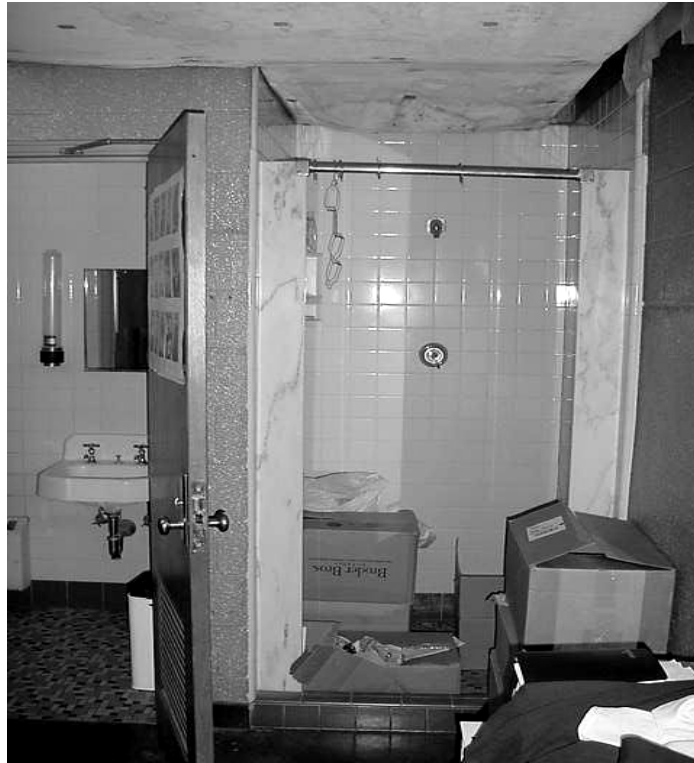
Picture 9

The girls' locker room has a shower that is not used (Picture 9). There does not appear to be local exhaust ventilation for the shower. Water damage and mold growth was observed on the ceiling above the shower. Located in the ceiling of the shower stall is an insulated ventilation duct. The insulated duct is connected to the aforementioned AHU and provides ventilation to locker room. Since the shower has no apparent local exhaust ventilation, use of the shower would result in the duct insulation becoming chronically moistened by water vapor. Use of this shower would perpetuate mold growth.

Shower Stall in Girls' Locker Room, Note Water Damaged Duct Insulation above Shower

14. Remove and replace water damaged insulation from the duct in the girls' locker room. Disable the showerhead and seal the floor drain to prevent further water damage to insulation. Operate the locker room ventilation system when the locker room and gymnasium office are occupied.

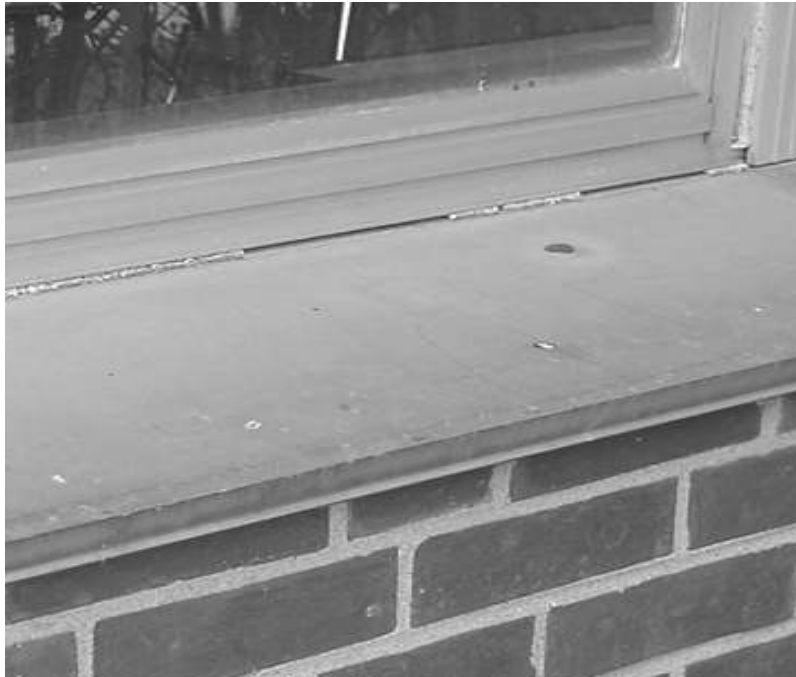
Picture 10

Exterior window and frame caulking was crumbling/damaged in a number of areas, indicating that the water seal is no longer intact (Picture 10). Water damaged plaster was noted around the interior of windows with corresponding exterior caulking damage (Picture 11). The damage is most likely attributable to water penetration around window frames during rainstorms. Replacement of caulking and repairs of window leaks are necessary to prevent water penetration. Repeated water damage can result in mold colonization of porous building materials, curtains and/or items stored on or around windowsills.

Missing/Damaged Caulking around Window Frames

3. Repair/replace missing or damaged window caulking building-wide to prevent water penetration through window frames. During this project it is recommended that all water-damaged materials be examined for microbial growth and structural integrity.

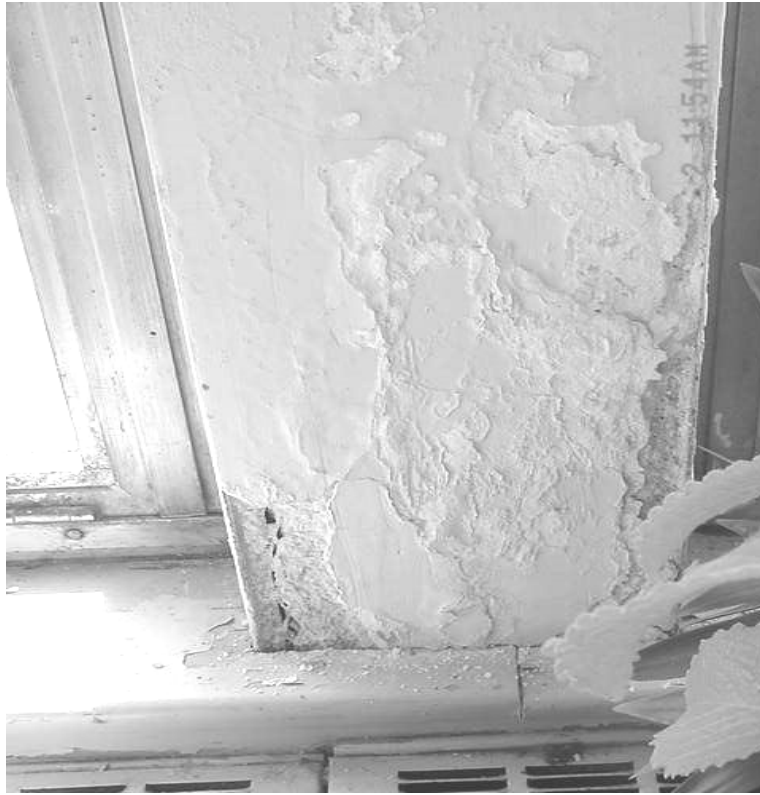
Picture 11

Water Damaged Wall Plaster between Window Frames

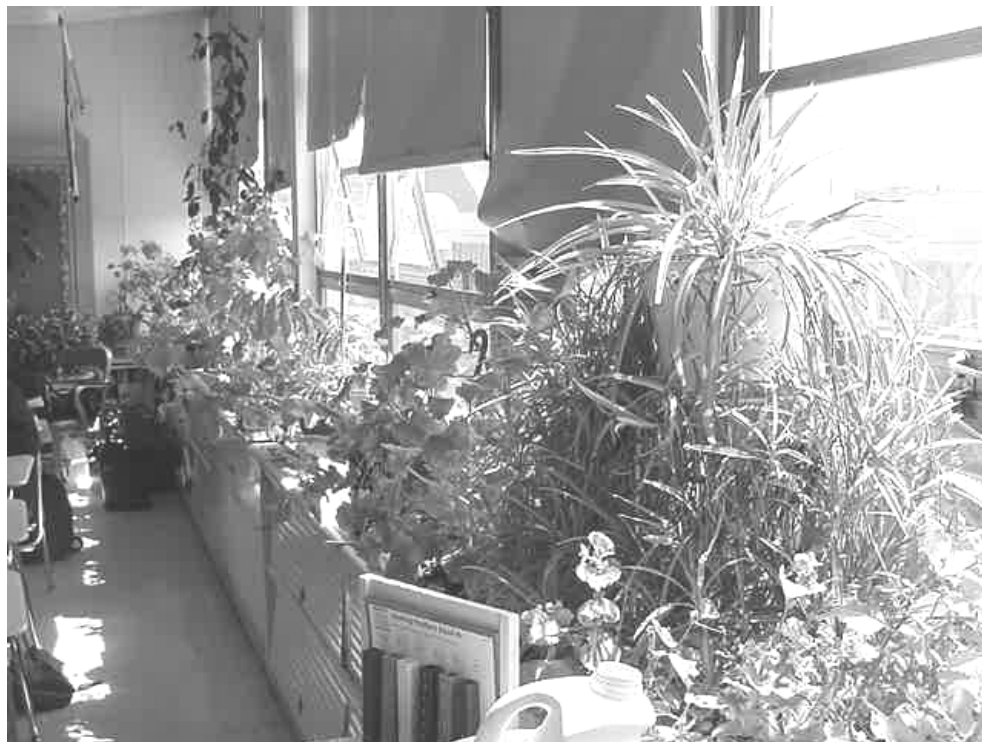
Picture 12

Plants and potting soil were located in many rooms, and several of the plants were on top of classroom univents and in close proximity to univent air intakes along the perimeter of the building (Pictures 12 and 13). Plant soil and drip pans can serve as a source of mold growth. Plants should be located away from the air stream of univents to prevent entrainment and aerosolization of dirt, pollen or mold. Several plants were noted in standing water (Picture 14). Stagnant water can be a source for bacterial/mold growth and unpleasant odors.

Plants on Top of a Classroom Univent Air Diffuser

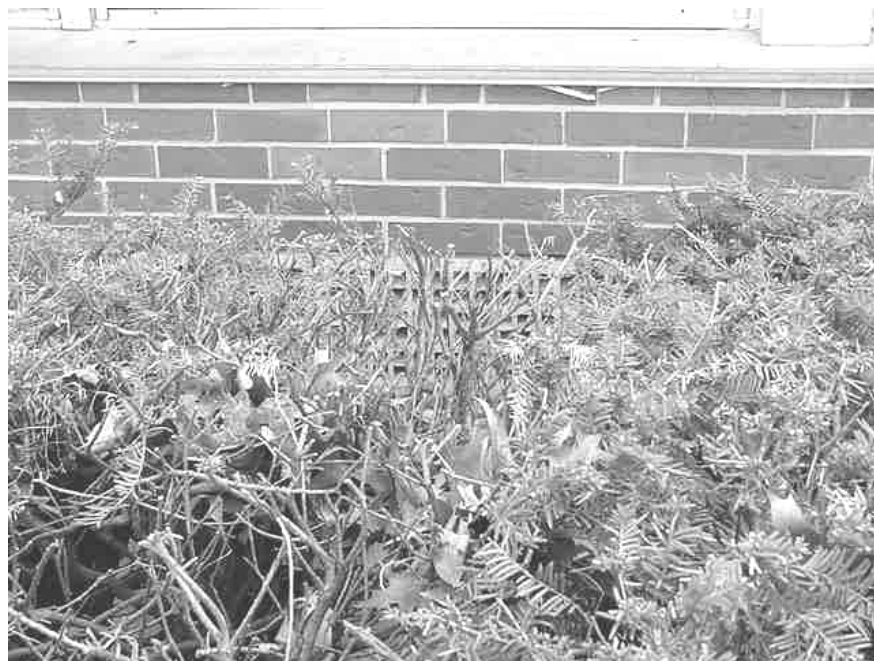
Picture 13

Plants/Shrubbery in Close Proximity to Univent Fresh Air Intake

15. Seal unused shower drains or pour water down regularly to prevent dry traps and associated odors.
16. Remove plant growths against the exterior wall/foundation of the building to prevent water penetration. Trim trees in rear of building away from brickwork.

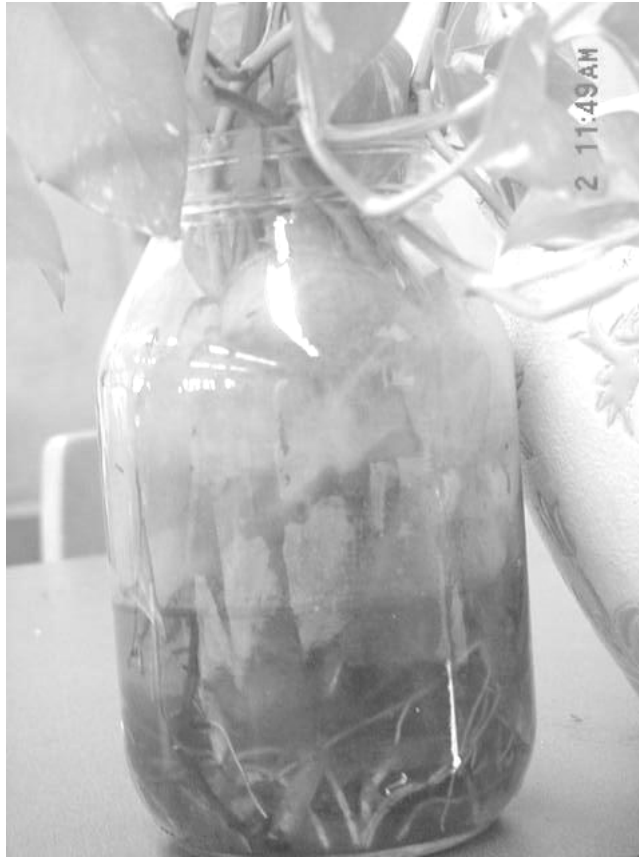
Picture 14

Plant in Standing Water, Jar Green with Algae/Mold Growth

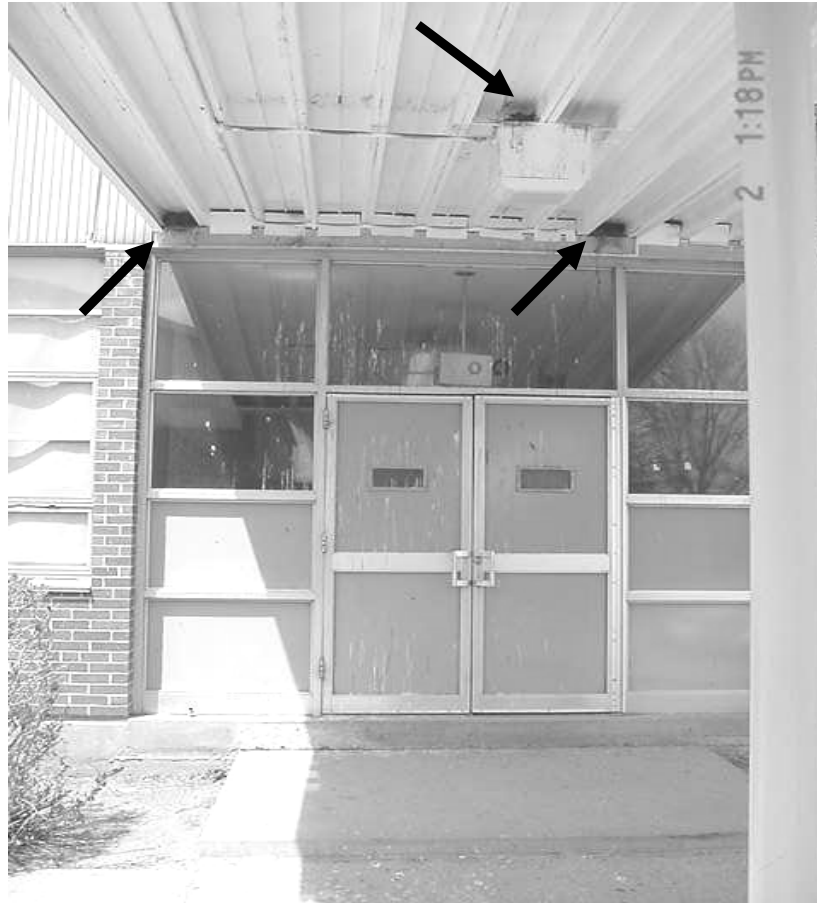
Picture 15a

Signs of bird roosting and nesting were observed in a number of recesses (e.g., overhangs, broken block windows) around the exterior of the building (Pictures 15a and 15b). No obvious signs of bird roosting inside the building or in ventilation components were noted by BEHA staff or reported by occupants. Birds can be a source of disease, and bird wastes and feathers can contain mold and mildew, which can be irritating to the respiratory system.

Birds Nests in Crevices of Walkway Overhang, Note Bird Wastes on Windows and Doors

9. Examine the feasibility of providing exhaust ventilation for room 4A.
10. Remove birds' nests from exterior of building and install bird screens as needed. To prevent possible exposure to bird wastes, implement the corrective actions recommended concerning remediation of bird wastes as described Appendix B. To prevent possible spread of bird waste particulates to occupied areas, employ the methods listed in the SMACNA guidelines for Containment of Renovation in Occupied Buildings (SMACNA, 1995).

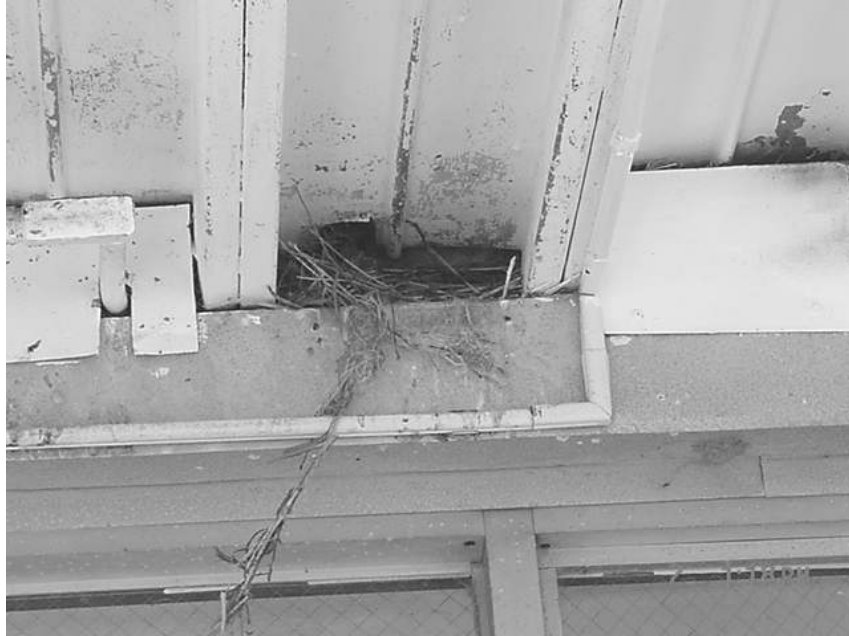
Picture 15b

Close up of Birds Nests in Crevice of Awning

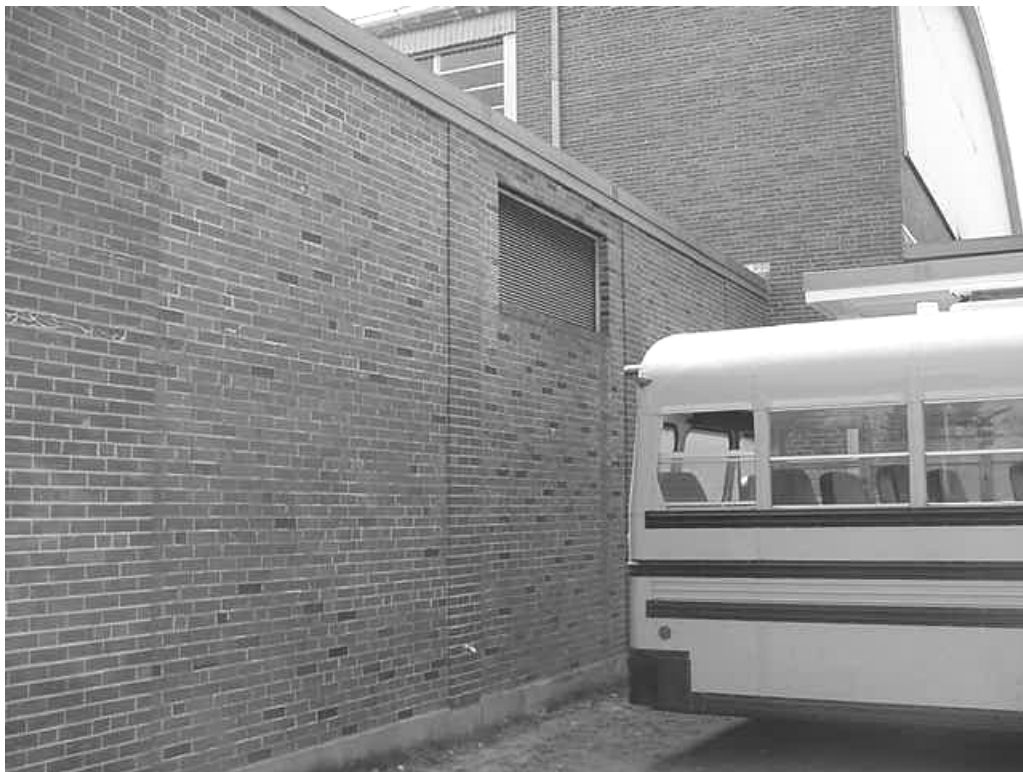
Several other conditions that can potentially affect indoor air quality were identified. Although no complaints of vehicle exhaust odors have been reported within the building, the potential for entrainment exists. Picture 16 shows a bus parked with the exhaust near an air intake. Picture 17 illustrates the close proximity of the employee parking lot to the building and the potential for vehicle exhaust to be drawn, or entrained, into the univent fresh air intakes. Idling vehicles produce vehicle exhaust that may become entrained in the ventilation system and become distributed in building; this may, in turn, provide opportunities for exposure to compounds such as carbon monoxide. M.G.L. chapter 90 section 16A prohibits the unnecessary operation of the engine of a motor vehicle for a foreseeable time in excess of five minutes (MGL, 1996).

Bus in Close Proximity to Air Intake

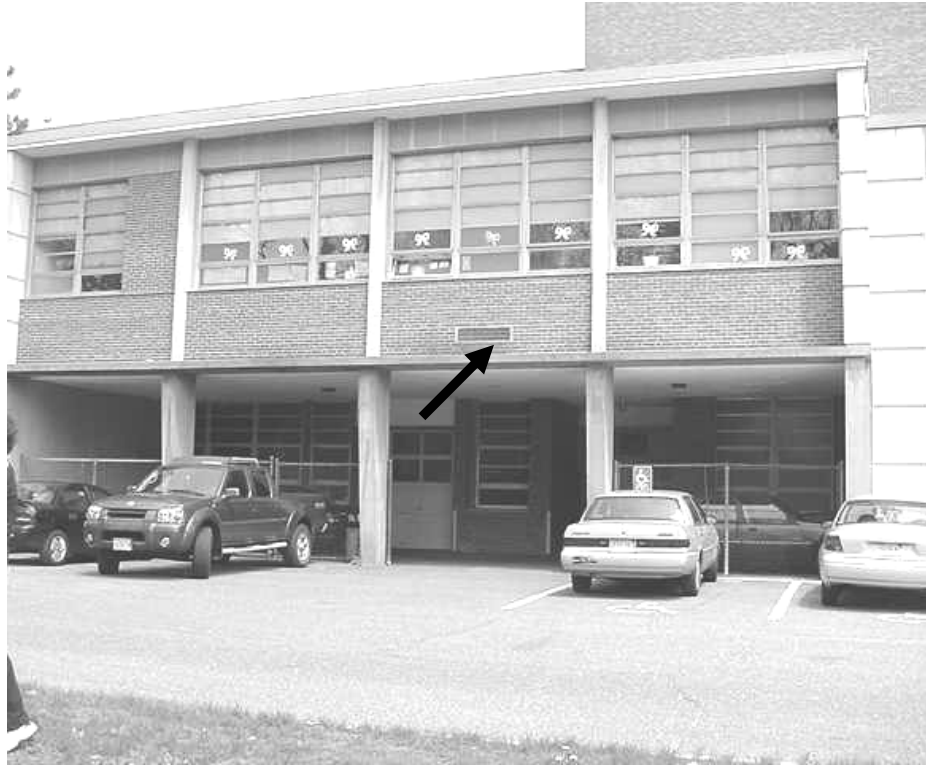
Picture 17

Cars Parked in Close Proximity to Classroom Univent Air Intake

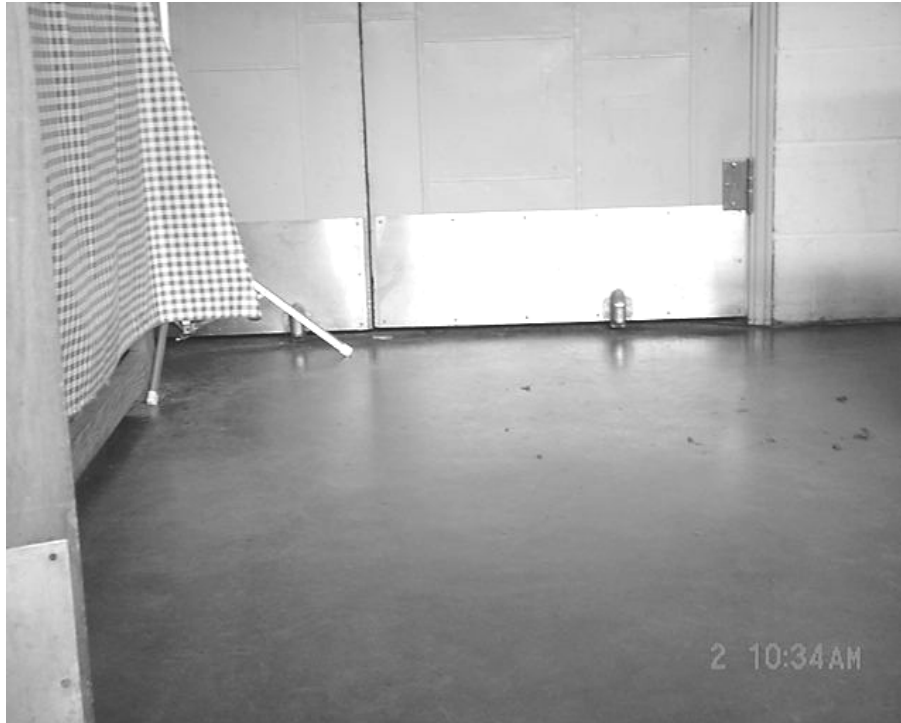
Picture 18

Fuel odors were reported in classroom 18, which is located adjacent to the maintenance garage. A pair of double doors connects classroom 18 to the garage (Picture 18). Large spaces were observed around the double doors, allowing odors from fuel containers and other maintenance equipment (e.g., lawn mowers/snow blowers) to migrate into the classroom.

Double Doors Connecting Classroom 18 To The Garage

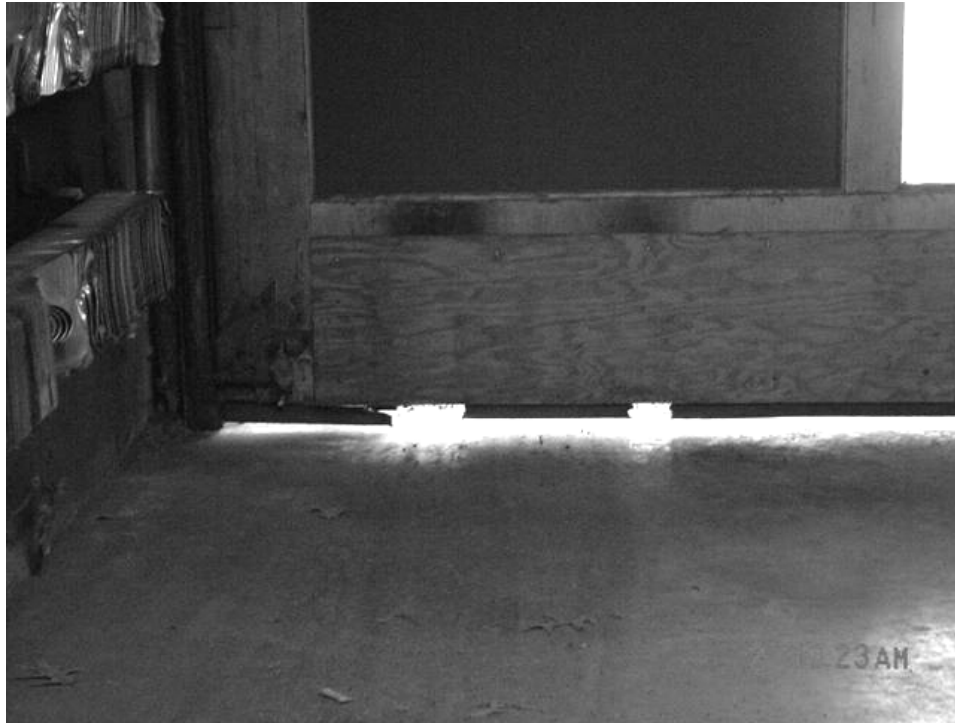
Picture 19

Of note is the location of the garage doors, which are located within a sheltered bay on the west wall of the school. Wind direction in New England is predominantly westerly (Trewartha, 1943). The erection of a sheltered bay facing west will tend to prevent wind from moving around the west wall, which then increases air pressure on the garage doors. The increased air pressure on the exterior door forces cold outdoor air into the garage through seams and holes in the outer door (Picture 19). Cold air then

pressurizes the garage interior, subsequently forcing air through spaces around the doors/frames into adjacent areas such as classroom 18 (Pictures 18 and 19). Under these conditions, odors and pollutants generated from materials stored in the garage and operation of vehicles and gasoline-powered equipment can migrate into areas adjacent to the garage.

Bottom of Garage Door, Note light penetration and torn door gasket

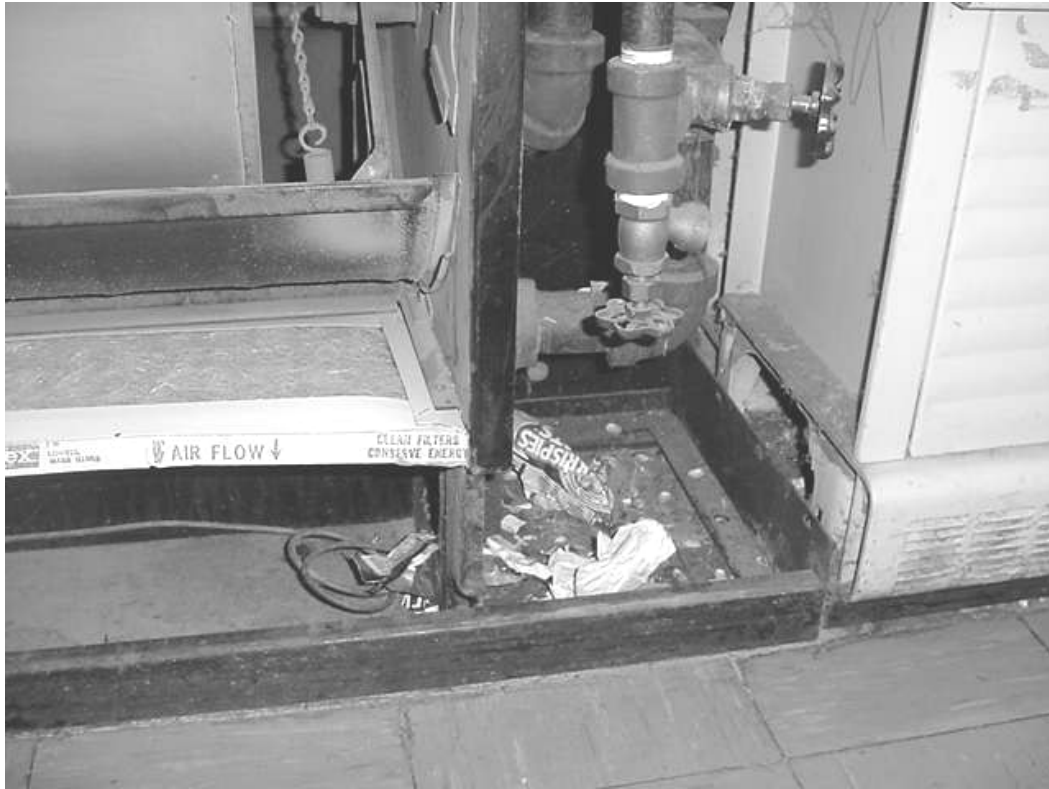
Picture 20

A number of univents had accumulated dirt, dust and debris within the air handling chambers (Picture 20). These conditions can be attributed to non-continuous univent use, allowing airborne particulates to settle within the units. In addition, AHUs that have been deactivated for prolonged periods of time (e.g., the locker rooms/gymnasium units) can also have an accumulation of dust and debris. In order to prevent equipment from serving as a source for aerosolized particulates, the air handling sections of the univents and AHUs should be regularly cleaned (e.g., during regular filter changes).

Accumulated Dirt, Dust and Debris in Univent Interior

21. Change filters for air-handling equipment, air purifiers and window-mounted air conditioners and as per the manufacturer's instructions or more frequently if needed. Vacuum interior of units prior to activation to prevent the aerosolization of dirt, dust and particulates. Ensure filters fit flush in their racks with no spaces in between allowing bypass of unfiltered air into the unit.
